Extensive type IIIB bone loss of the acetabulum and suitability of 3D printings during planning

Filip DF, Snela S, Przeszłowski Ł, Łazorko A, Dziura W. Extensive type IIIB bone loss of the acetabulum and suitability of 3D printings during planning. *J Pre-Clin Clin Res.* 2021; 15(2): 63–67. doi: 10.26444/jpccr/135744

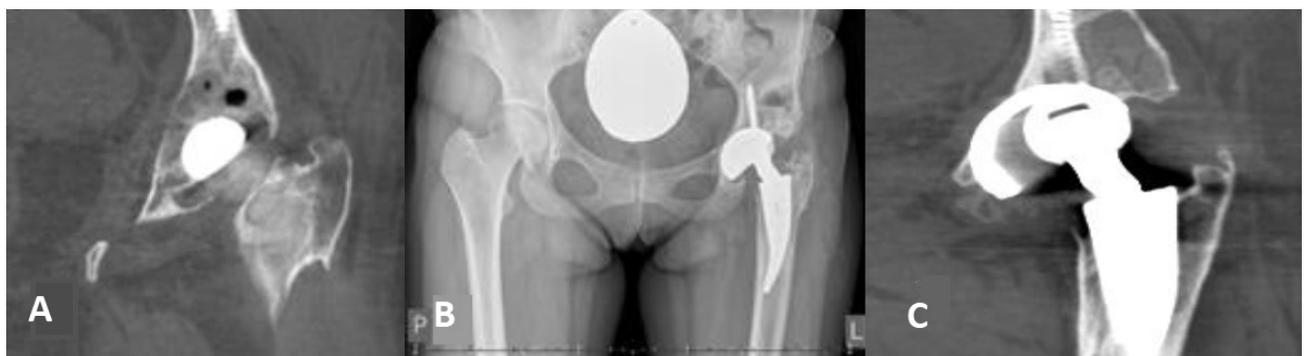
Figure 1. A-C. X-ray and CT images of the pelvis with loose parts of the prosthesis, bone defect of the acetabulum and femur and damage to the polyethylene liner and the acetabular shell

A 31-year-old patient was admitted to our Department in December 2019 due to severe pain in the hip joint, difficulty in movement, with the symptoms of jumping in the hip joint, radiolucent changes surrounding the acetabular and femoral implants, and damage to the polyethylene liner and the acetabular shell (Fig. 1).

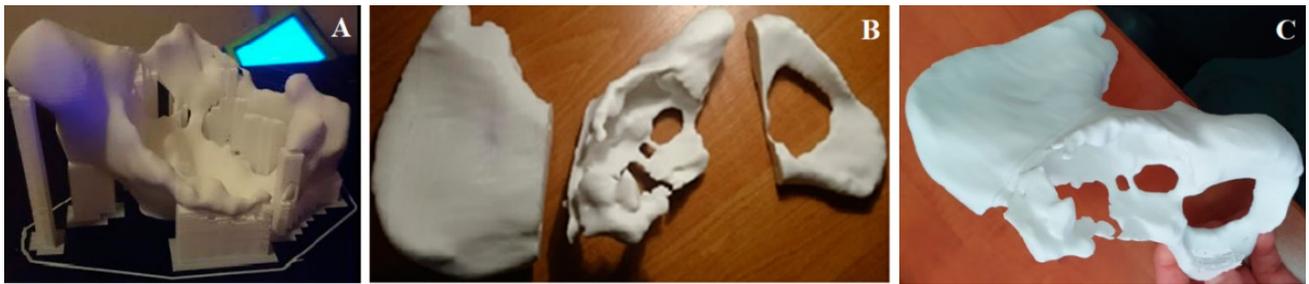
Figure 6. A-C, 3D prints of the pelvic bones. A – 1 of 3 parts with supports. B – 3 parts without supports. C – 3 parts connected together

The finished medical model was divided into three parts. The printouts were made in FDM (Fused Deposition Modeling) technology, that is, as a result of the deposition of subsequent layers of melted thermoplastic PLA (Polylactide). The layer height was set at 0.2 mm, thanks to which a high quality of the print surface was obtained. It was decided to divide the model into three parts due to the number of details (Fig. 6). Each part of the 3D model was printed for a total of about 12–14 hours. If it had been printed in one piece, the process would have taken about 18 hours. Moreover, there would be more supports, the removal of which could easily damage the model [14, 15].

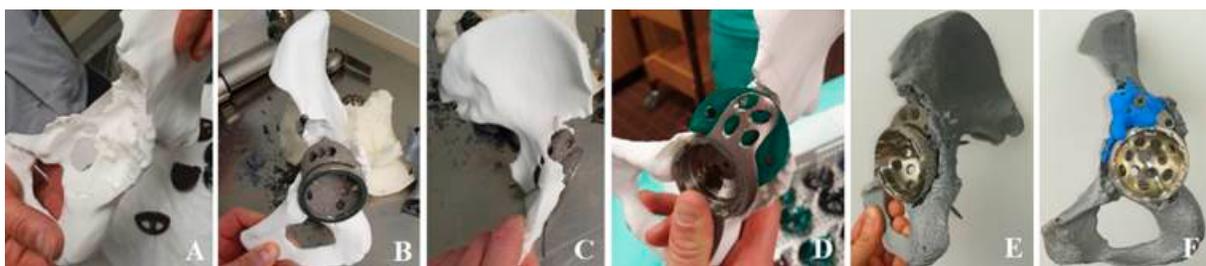
Figure 8. A-F. Preoperative planning

After analyzing the performed diagnostic tests, trialing on 3D printed bone models and consultation with the revision specialists, the patient underwent the operation on 24 March 2020, with an extended proximal lateral approach (Fig 7,8). The cement SPACER was removed. After cleaning the bottom of the acetabulum and gently reaming, the bottom was filled with compacted bone allografts and a small amount of Stimulan with vancomycin and gentamycin. The next step was to implant a Regenerex augment size 52 S (Zimmer-Biomet), with additional stabilization using two titanium screws with a diameter of 6.5 mm. At a later stage of the procedure, the G7 Osseo Ti 60mm (Zimmer-Biomet) revision cup was implanted and additionally stabilized with eight screws. Between the cup and the augment, a small amount of bone cement was added. An asymmetric polyethylene liner with vitamin E was subsequently implanted. Next, after careful gradual reaming of the medullary canal of the femur, a Wagner SL revision stem (Zimmer-Biomet) was implanted. The last step was the implantation of a ceramic head with a diameter of 36 mm. The remaining amount of Stimulan
