Revision of total knee arthroplasty in a patient with aseptic loosening caused by reaction to polyethylene – Case Report

Michalak K, Janowski K, Rulewska NM, Grabowski F. Revision of total knee arthroplasty in a patient with aseptic loosening caused by reaction to polyethylene – Case Report. J Pre Clin Clin Res. 2025;19(2):60–63. doi:10.26444/jpccr/204550

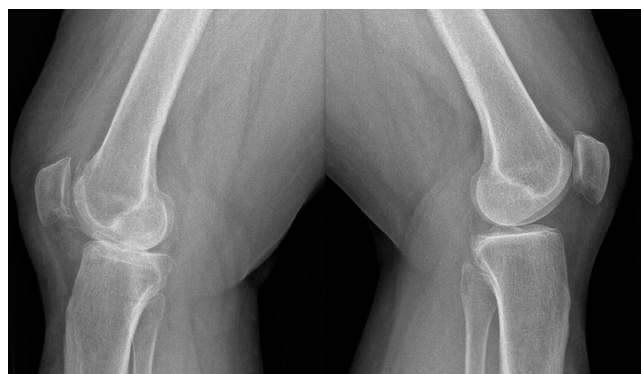
Figure 1. X-ray of the right knee joint with visible signs of degeneration

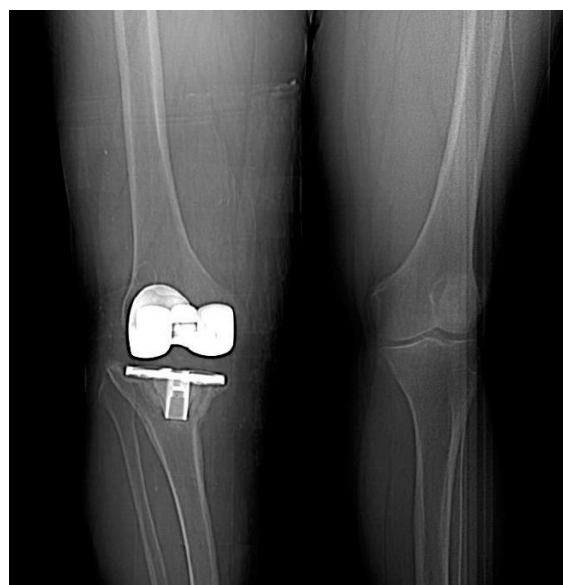
In November 2022, the patient reported to the orthopedic clinic due to pain in the right knee. The CT scan performed showed loosening and medial positioning of the tibial component of the prosthesis and a comminuted periprosthetic fracture of the medial condyle of the right tibia (Fig. 3). The patient was qualified for revision arthroplasty. During the procedure, inflamed knee joint tissues and excess cement fixing the prosthesis were revealed (Fig. 4).

Figure 3. Computed tomography of the right knee joint showing loosening of the prosthetic elements and a periprosthetic fracture

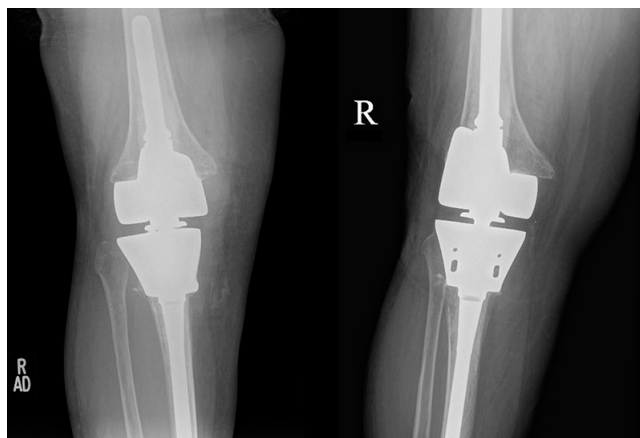
Synovial fluid was collected for bacteriological tests, and 5 fragments of the synovial membrane were sent for histopathological examination. The revision surgery was performed without complications, and the control X-ray performed after the procedure did not reveal any abnormalities (Fig. 5). No microbial growth was detected in synovial fluid samples. The result of histopathological examination confirmed the presence of inflammation in the

Figure 5. X-ray of the right knee joint after revision surgery. Correct positioning of the prosthetic elements
