ECG movement artefacts can be greatly reduced with the aid of a movement absorbing device

Abstract: Accurate ECG signal analysis can be confounded by electric lead, and/or electrode movements varying in origin from, for example, hiccups, tremor or patient restlessness. ECG signals recorded using either a conventional electrode holder, or with the aid of an electrode holder capable of absorbing movement artefacts, were measured on a healthy human subject. Results show a greatly improved stability of the ECG signal recorded using an electrode holder capable of absorbing movement artefacts during periods of lead disturbance, and highlight the movement artefacts that develop when the recording lead of a conventional ECG electrode holder is tugged or pulled during the period of monitoring. It is concluded that the new design of ECG electrode holder will not only enable clearer signal recordings for clinical assessment, but will reduce the ECG artefacts associated with the transportation of patients, and may also reduce the time spent by hospital personnel answering ECG alarms that are the result of patient movement.

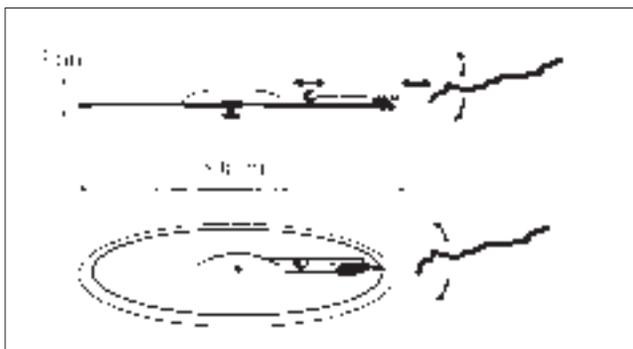
Figure 1 Line drawing of an ECG electrode modified to incorporate a device capable of absorbing movement, according to Patent No. PA 1998 01020. Note that the sensor in the centre of the ECG electrode, which is in contact with the patients skin, maintains a constant electrical contact *via* a 'silver piston' with the recording lead, by means of an electrolyte. The 'silver piston' and its holder are capable of absorbing movement in 3 different axes.

Standard commercial ECG electrodes (Blue Sensor type VL00S; Medicotest A/S, Ølstykke, Denmark) with or without the addition of a device capable of absorbing movement (Fig. 1, Patent No. PA 1998 01020), were applied to a healthy male human subject, aged 33 years. Although only one subject was used in this study, it is considered that the results more than adequately illustrate the potential of the device shown in Fig. 1 in terms of reducing ECG artefacts, which was the primary intention of the authors. A standard 5 lead ECG setup with
